FIELD TEST EVALUATION REPORT

IVECO TRUCK (2015-3)
CouplerTec 10COMM (2015-12)

Ljubljana, 17. 10. 2016

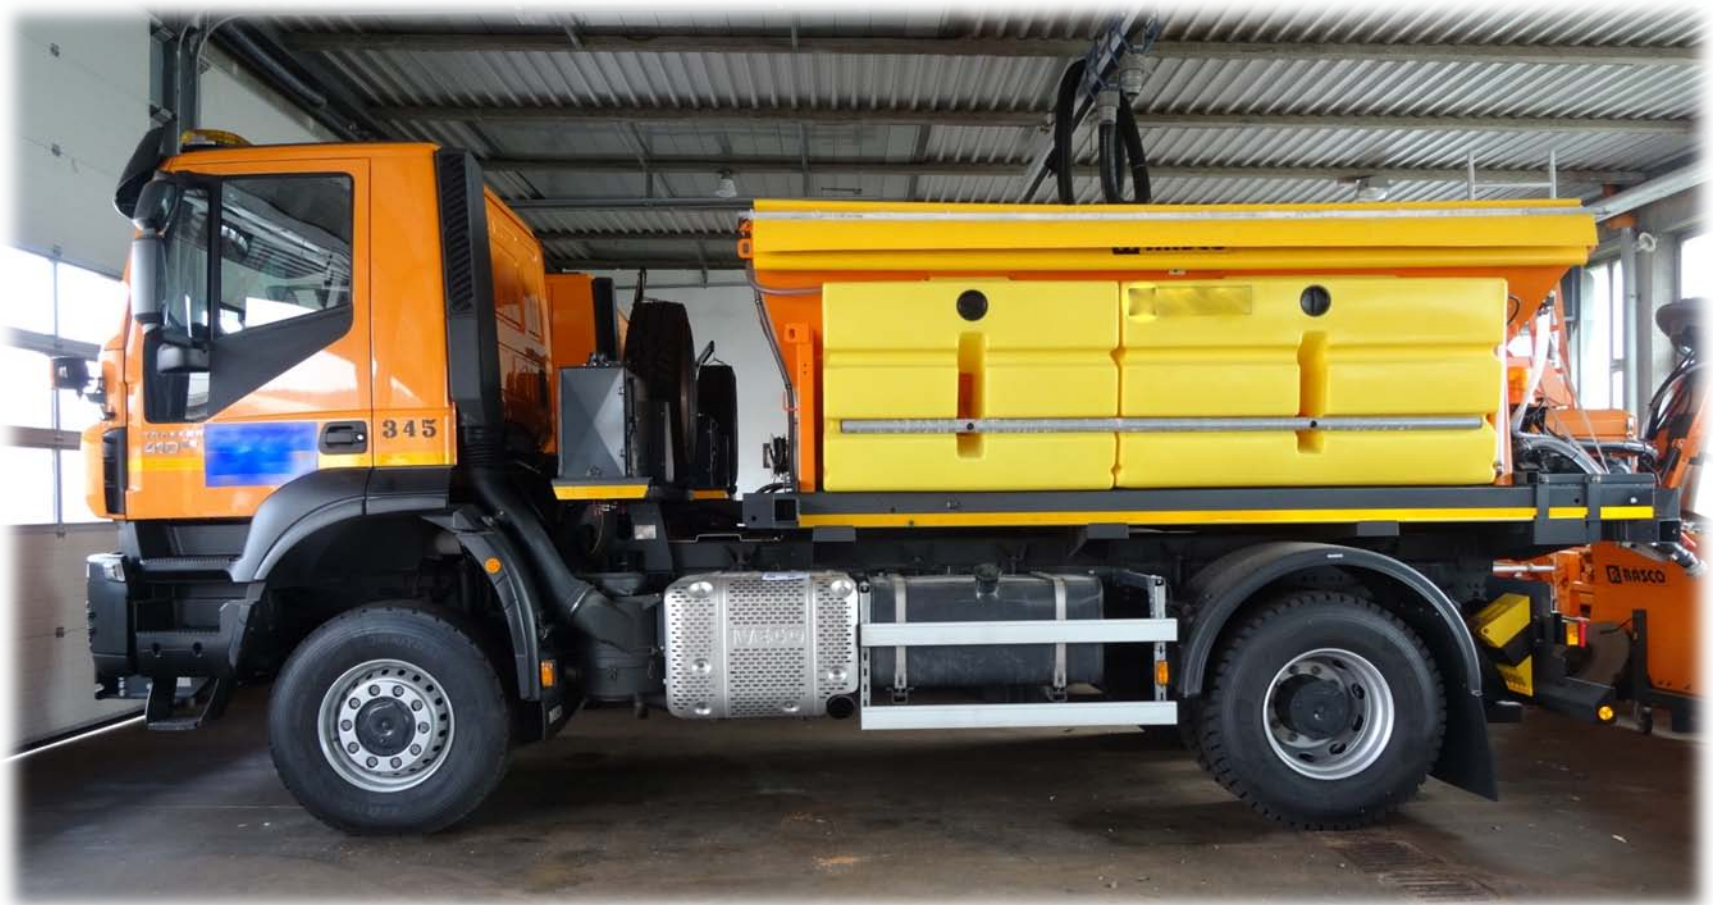
Time INTERVAL: 3 yrs dec 2015 Vs. okt 2016

BEFORE vs AFTER

Remark: It is not unusual for commercial (also other vehicles) to be rusty already as new. This comparison shows a stabilization of the rust process. There is no progress of rust detected. Also existing rust shown on later photo is darker (inactive ferric oxide).

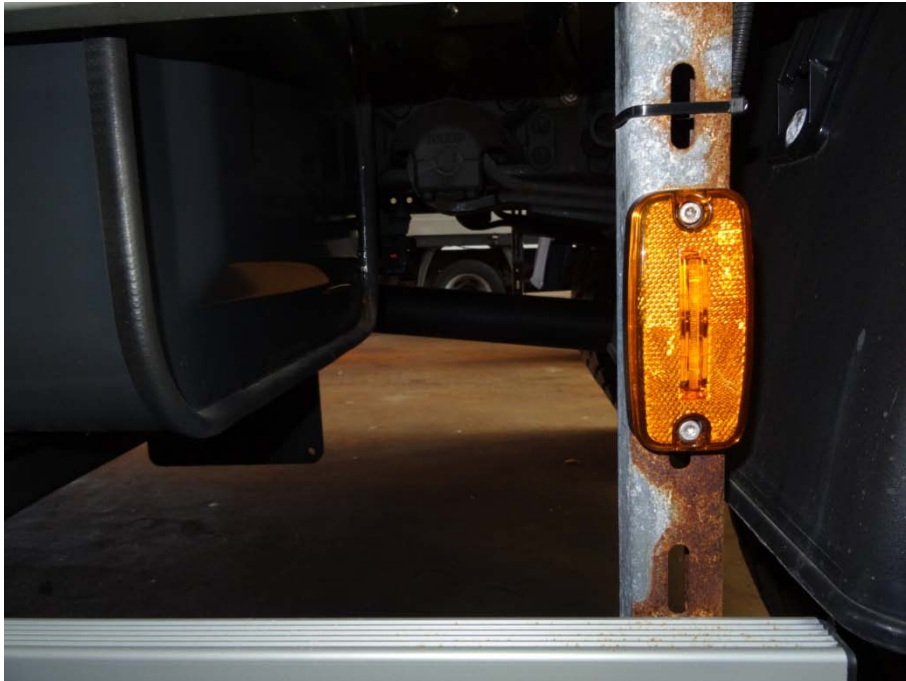
Conventional rust protection ONLY

Remark: Some “upgrades” are of lower quality (e.g. no paint, less galvanized) , therefore more prone to rust. Part on CouplerTec protected vehicle clearly has advantage.

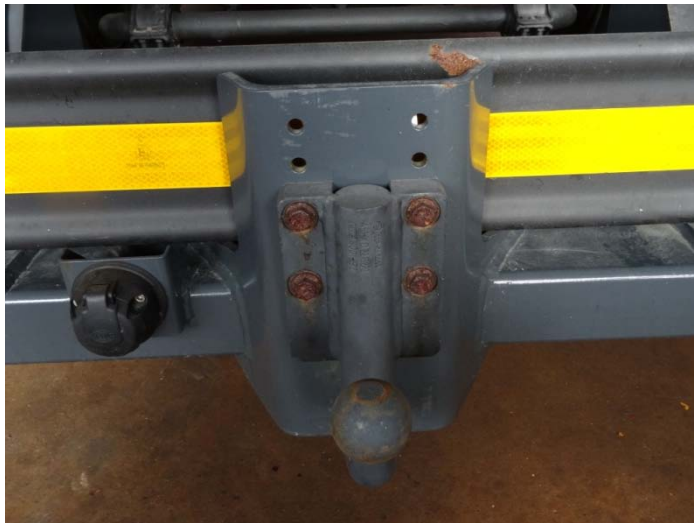
Conventional rust protection ONLY

Remark: Some “upgrades” are of lower quality (e.g. no paint, less galvanized) , therefore more prone to rust. Photo on left clearly speaks in CouplerTec’s advantage .

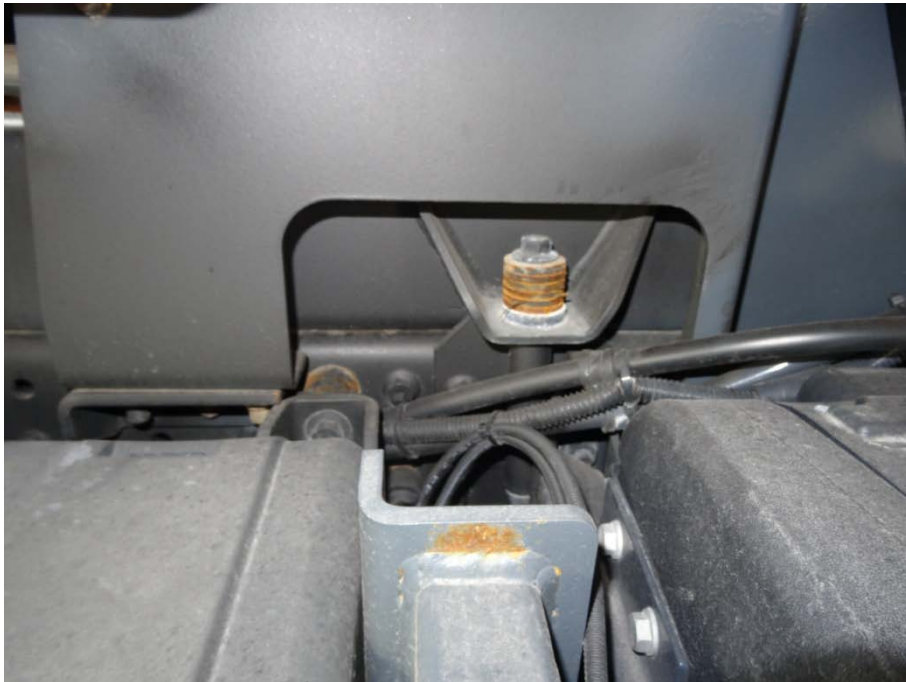
Conventional rust protection ONLY

Remark: Flat washers are unfortunately of very poor quality (e.g. no paint, not galvanized) , therefore more prone to rust. However flat washers protected with CouplerTec have darker colour indicating inactive ferric oxide. Poor quality parts will still rust but much slower.

Part in front is more rusty on vehicle without CouplerTec.
