# FIELD TEST EVALUATION REPORT

**TEREX TLB890, 2013**  
**CouplerTec 6COMM**

**Vehicle:** **TEREX TLB890** Backhoe Loader, **2013**

# TIME INTERVAL: 3 YRS DEC 2013 VS. OKT 2016

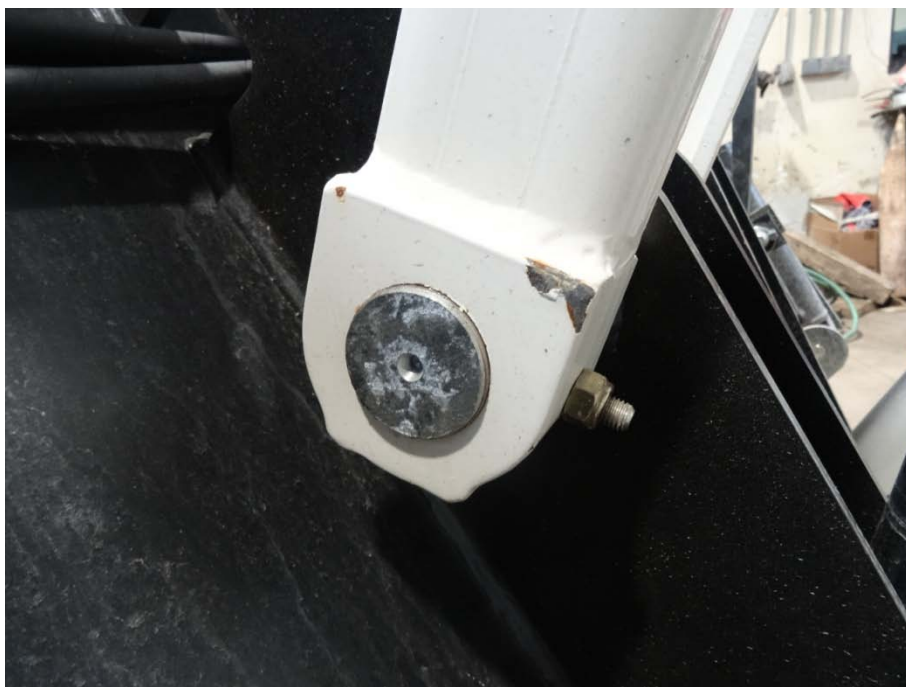
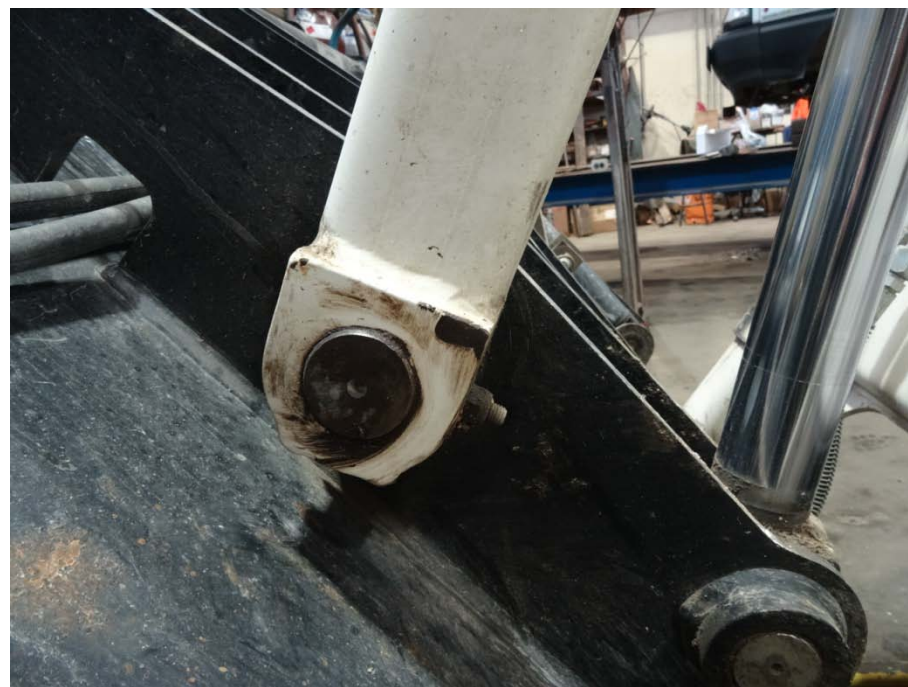
An area of damaged part (scratched paint) looks same. After time it only got darker, which indicates inactive ferric oxide as a consequence of CouplerTec rust protection.

**2013-12** (installation)

**2016-10**

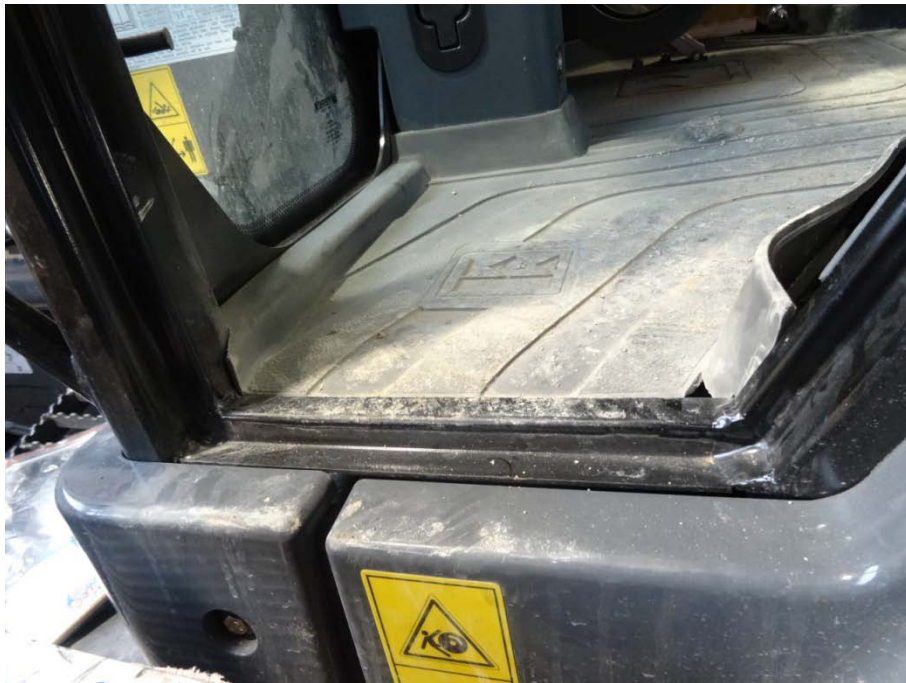
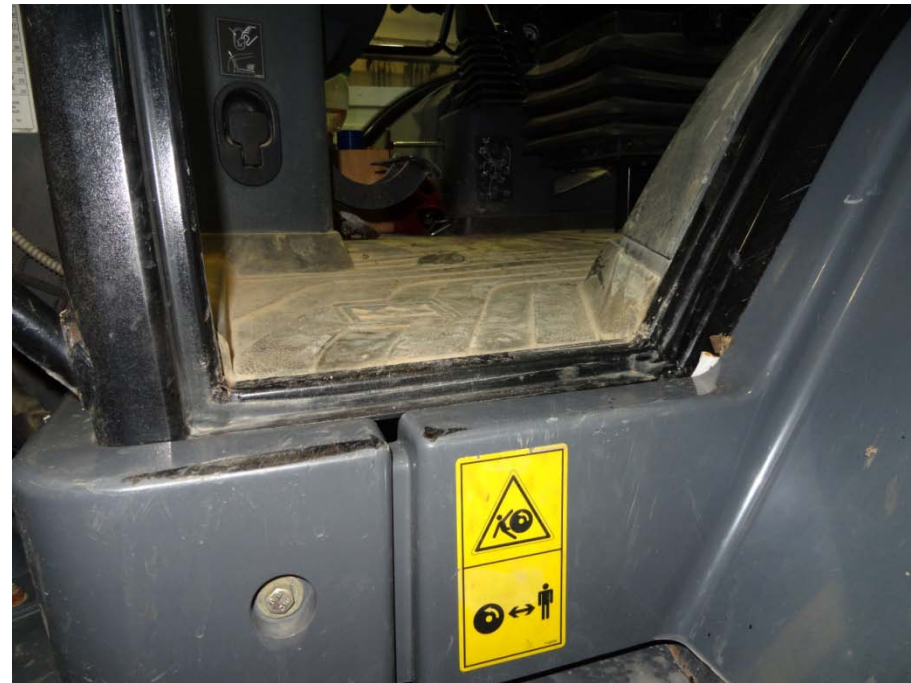
Heavily used and exposed cabin door area is very prone to rust. In this example the area haven't aged.

**2013-12 (installation)**

**2016-10**

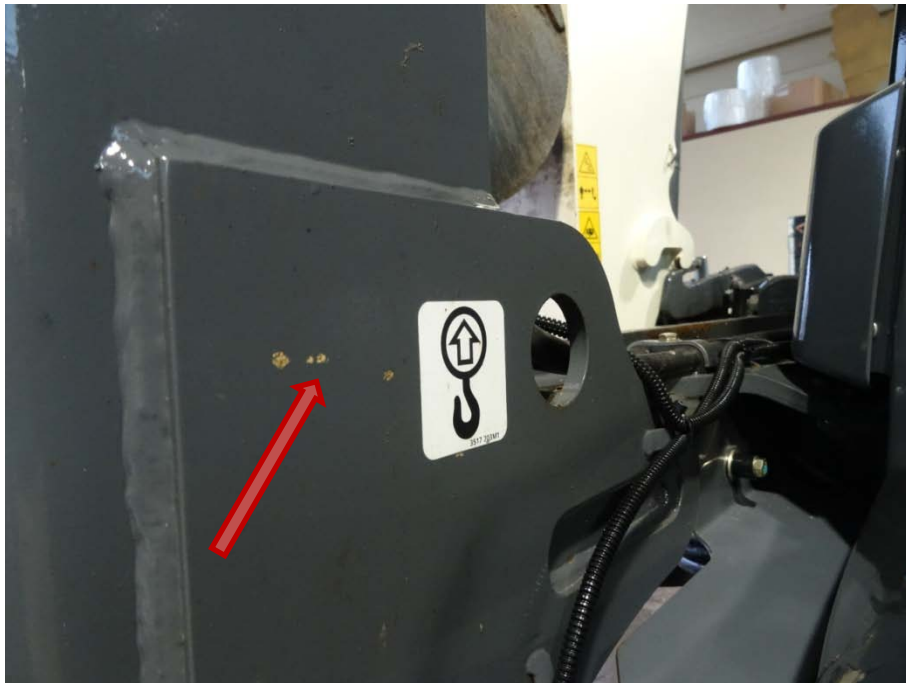
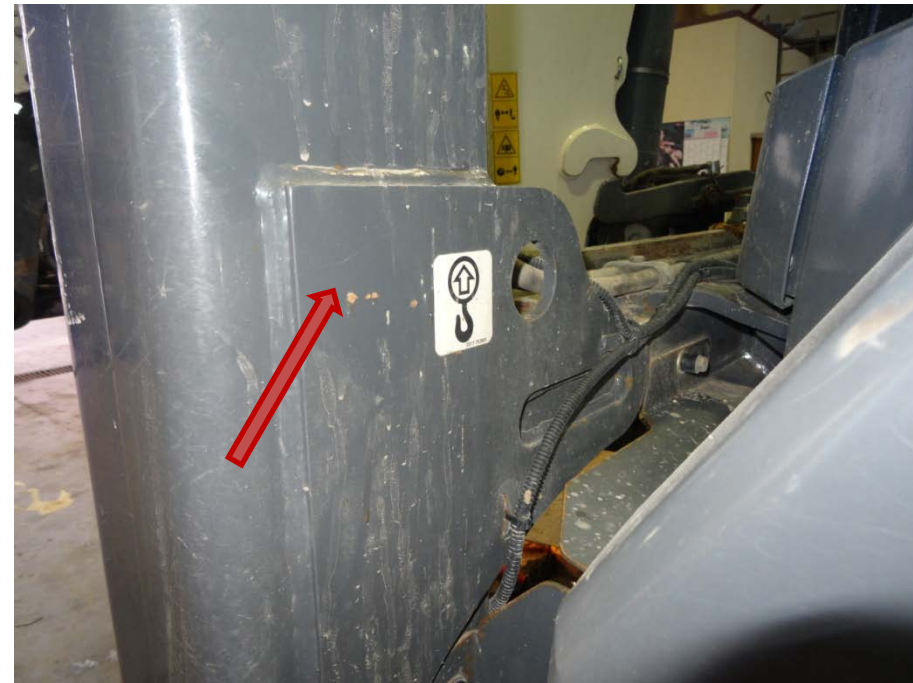
Damage (scratched paint) happened when loader was approximately one year old. In 2 years damaged area haven't aged.

**2014-11**

**2016-10**

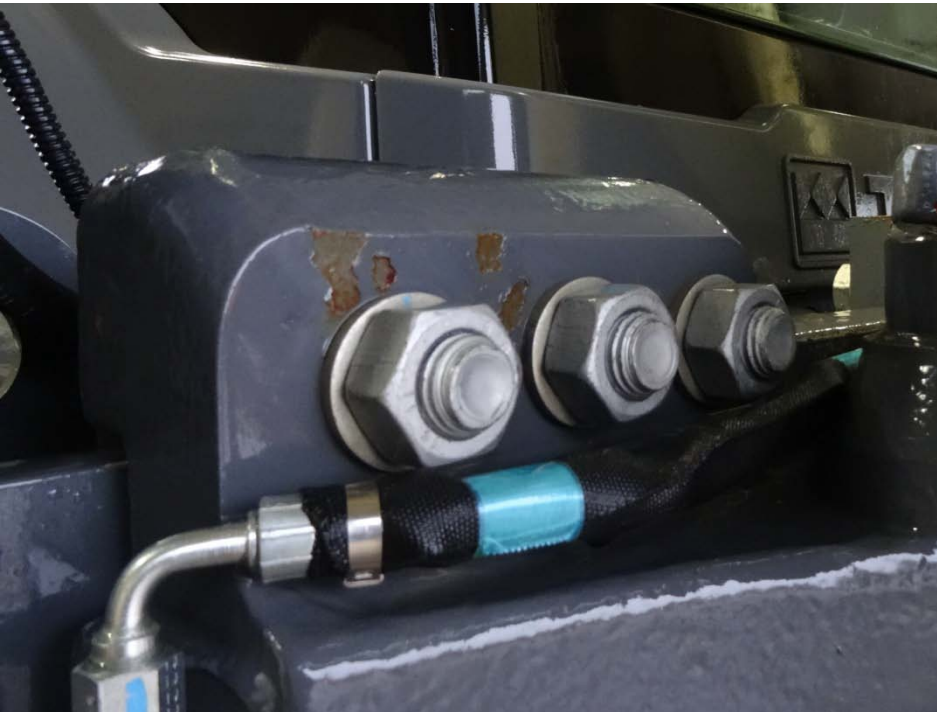
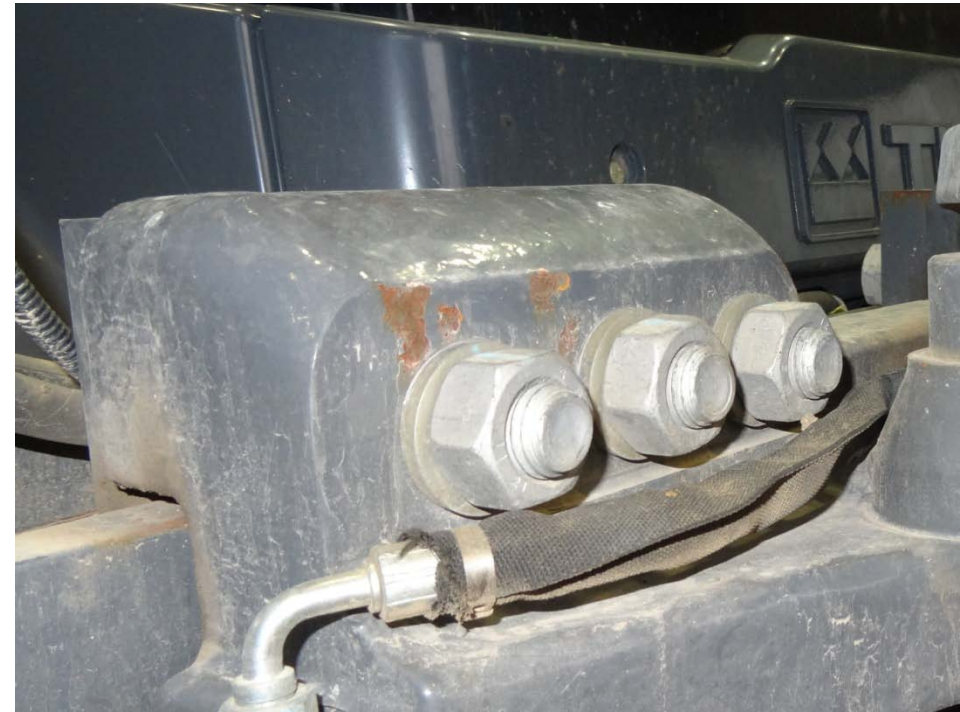
Damage (scratched paint) happened when loader was approximately one year old. In 2 years damaged area haven't aged.

**2014-11**

**2016-10**

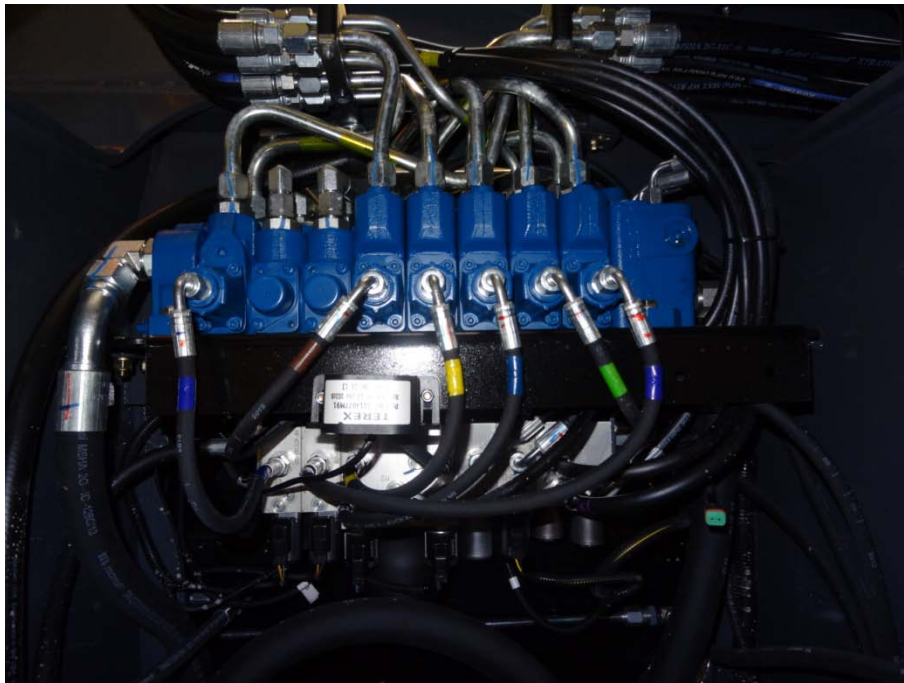
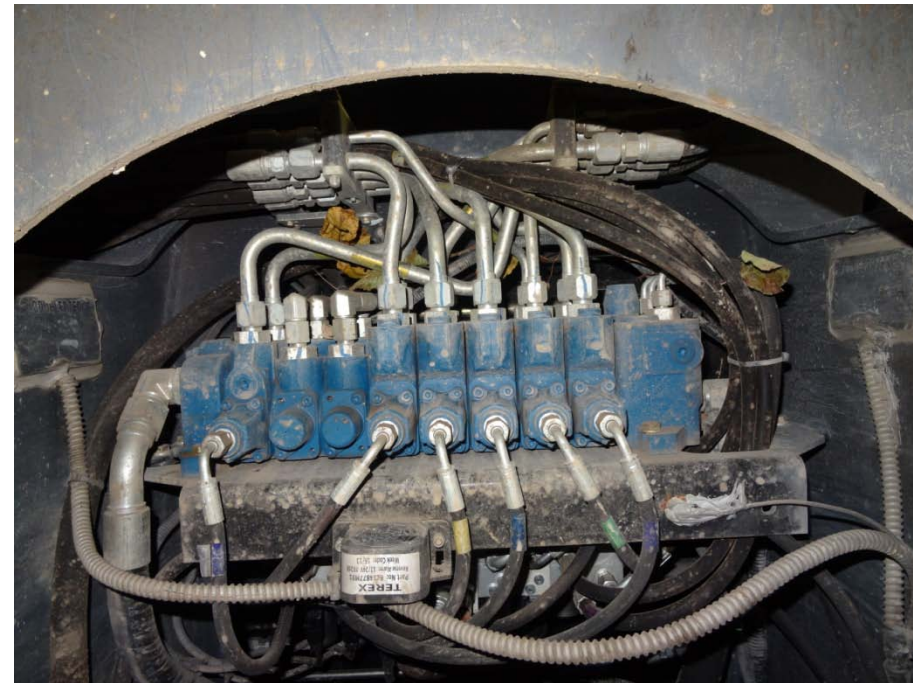
Chassis connections are constantly exposed to hard environmental elements. After 3 years they haven't aged.

**2013-12 (installation)**

**2016-10**

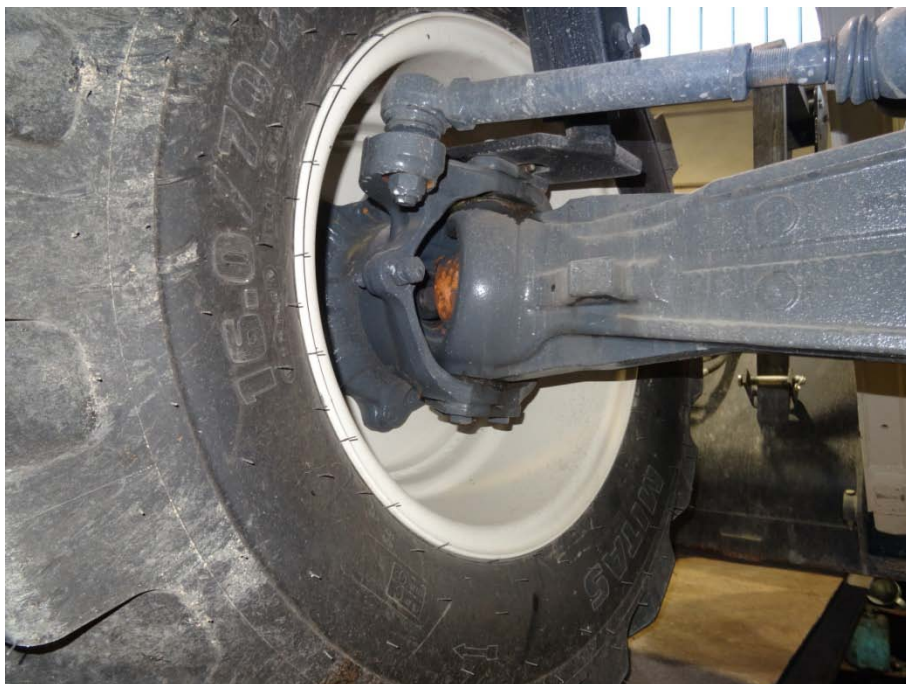
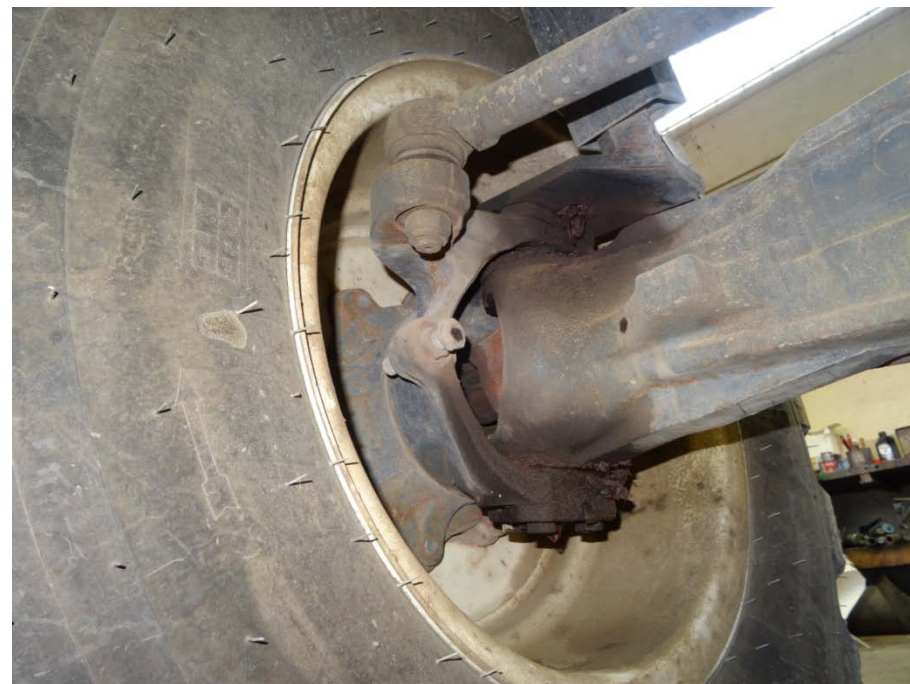
A very illustrative example of integrated rust already in the new vehicle (photo on left).

Underbody parts are especially exposed to harsh environmental elements e.g. stone chips, scratches, rust accelerators (slat, soil, minerals) and are more prone to rust. Underbody of this CouplerTec protected loader is after 3 years of heavy duty work in a very good condition.

**2013-12 (installation)**

**2016-10**

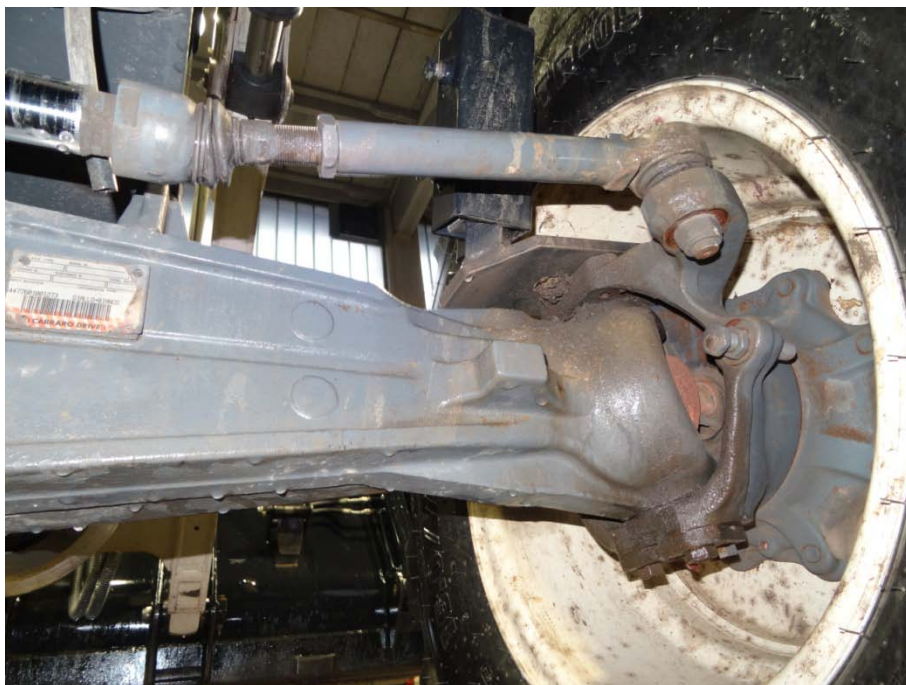
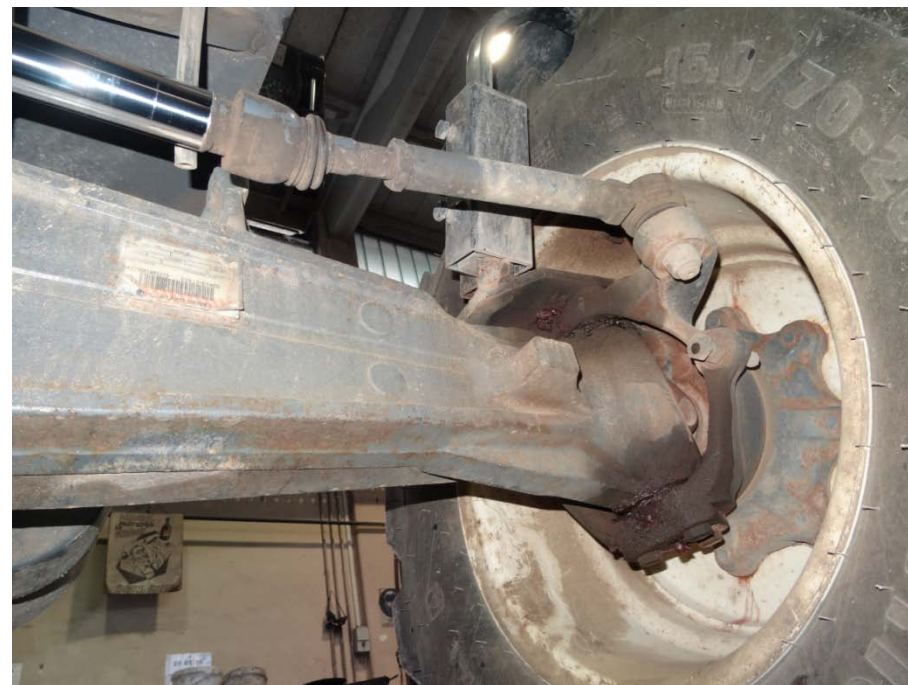
A very illustrative example of integrated rust already in the new vehicle (photo on left).

Underbody parts are especially exposed to harsh environmental elements e.g. stone chips, scratches, rust accelerators (slat, soil, minerals) and are more prone to rust. Underbody of this CouplerTec protected loader is after 3 years of heavy duty work in a very good condition.

**2014-11**

**2016-10**

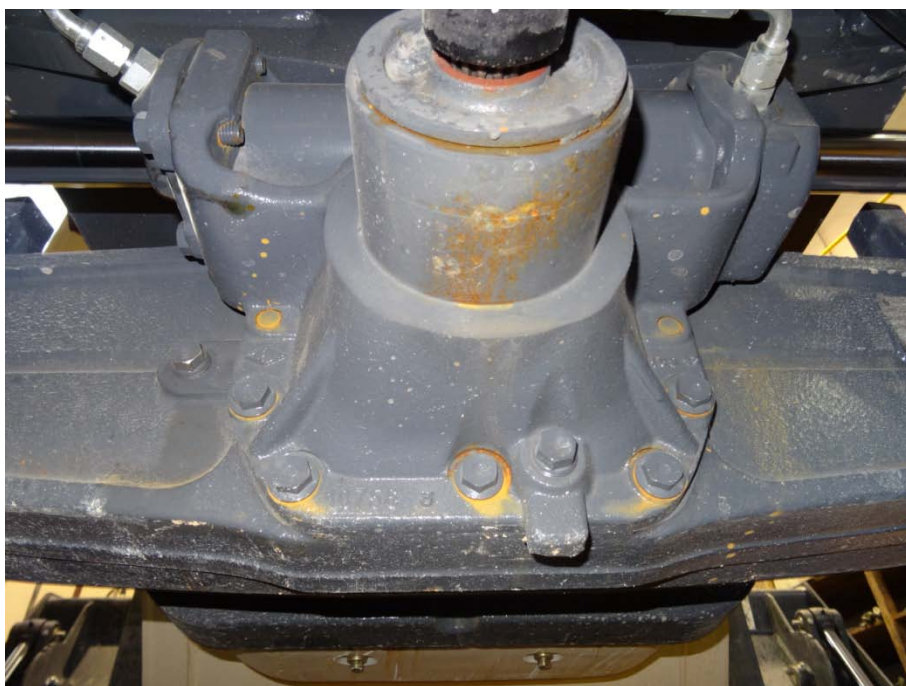
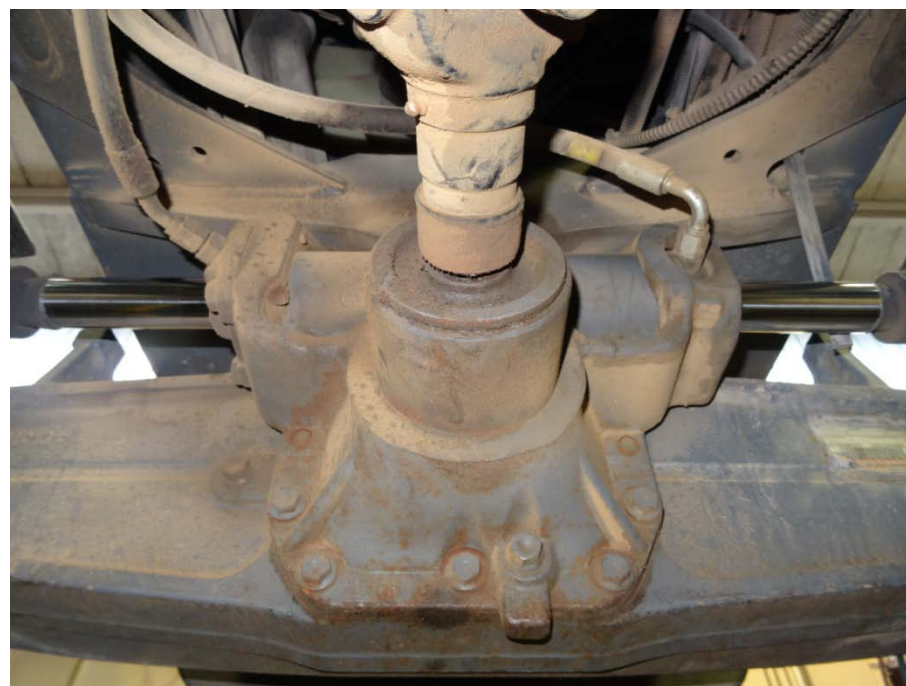
A very illustrative example of integrated rust already in the new vehicle (photo on left).

Underbody parts are especially exposed to harsh environmental elements e.g. stone chips, scratches, rust accelerators (slat, soil, minerals) and are more prone to rust. Underbody of this CouplerTec protected loader is after 3 years of heavy duty work in a very good condition.

**2013-12 (installation)**

**2016-10**
